## Update on Bbos water issues

Following last week's storm and power outage most properties in Bbos experienced murky/black water once the power eventually returned. Several properties have been affected in the past and some have also been affected again in the past week.

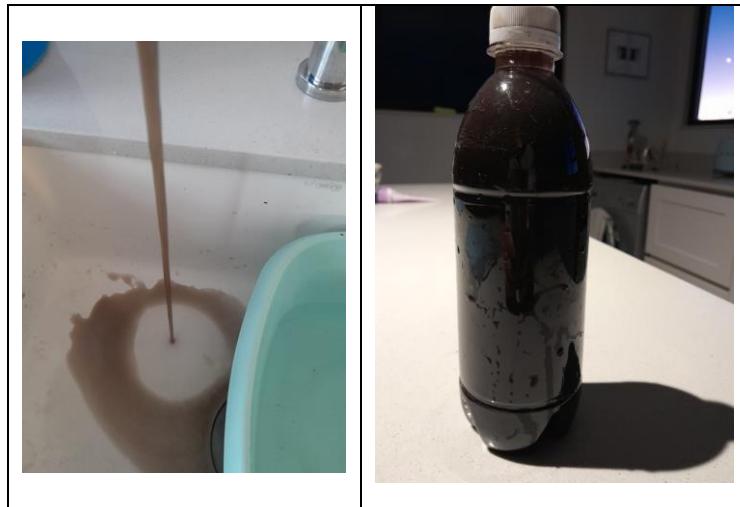
The morning (06.00) after the power returned this is what our water looked like in Olienhout.

I sent these pictures through to the municipality engineers and they agreed it looked like sediment - likely manganese or iron given the dark colour. The local soil has a high content of these metals, which is removed at the treatment plant. Their presence in the water would suggest soil/sediment is getting into the pipes.

<b>BBos 20 Olienhout Str. Samples</b>			
Paul Giess	0761481969	<a href="mailto:paulgiess@yahoo.com">paulgiess@yahoo.com</a>	
<b>Time</b>	<b>06.00 hrs</b>	<b>12.31 hrs</b>	
Colour	>500	6	PtCo
pH	9.7	8.74	
EC	78.4	58.4	mS/m
Turbidity	4355	0.59	NTU
Fe	95.2	0.05	mg/l
Mn	>16	0.1	mg/l

The 06.00 sample was clearly way off acceptable drinking water quality according to South African National Standards (SANS 241) [e.g., Turbidity should be < 1 NTU and Mn should be < 0.5 mg/l].

**The results indicate that the black water as experienced early in the morning was most probably caused by the empty water network being refilled which stirred up sediment in the pipes and caused the high turbidity and manganese readings in the morning.**

**It is the municipality's intention to install a generator and additional tanks to enable the more continuous operation of the treatment works and boreholes, and to reduce the regular stop/start scenario caused by load shedding, if the necessary funding can be secured for this purpose.**

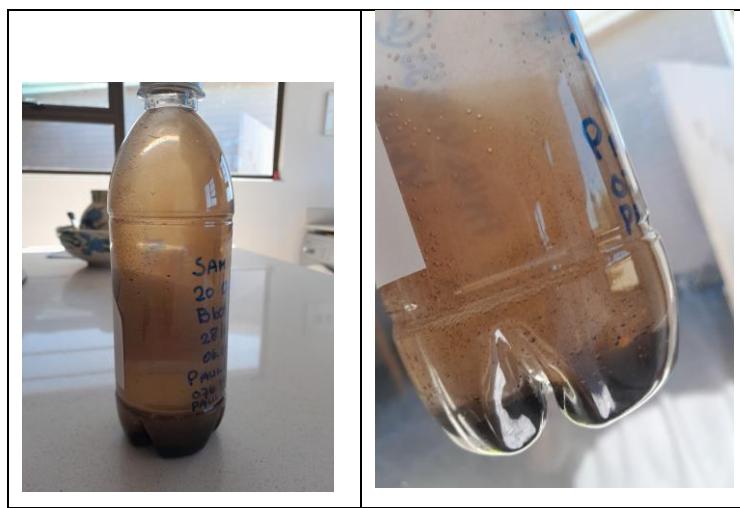
Over the next 2-3 hours sediment settled out of the water.
